Guidance note on the management of fire damaged asbestos

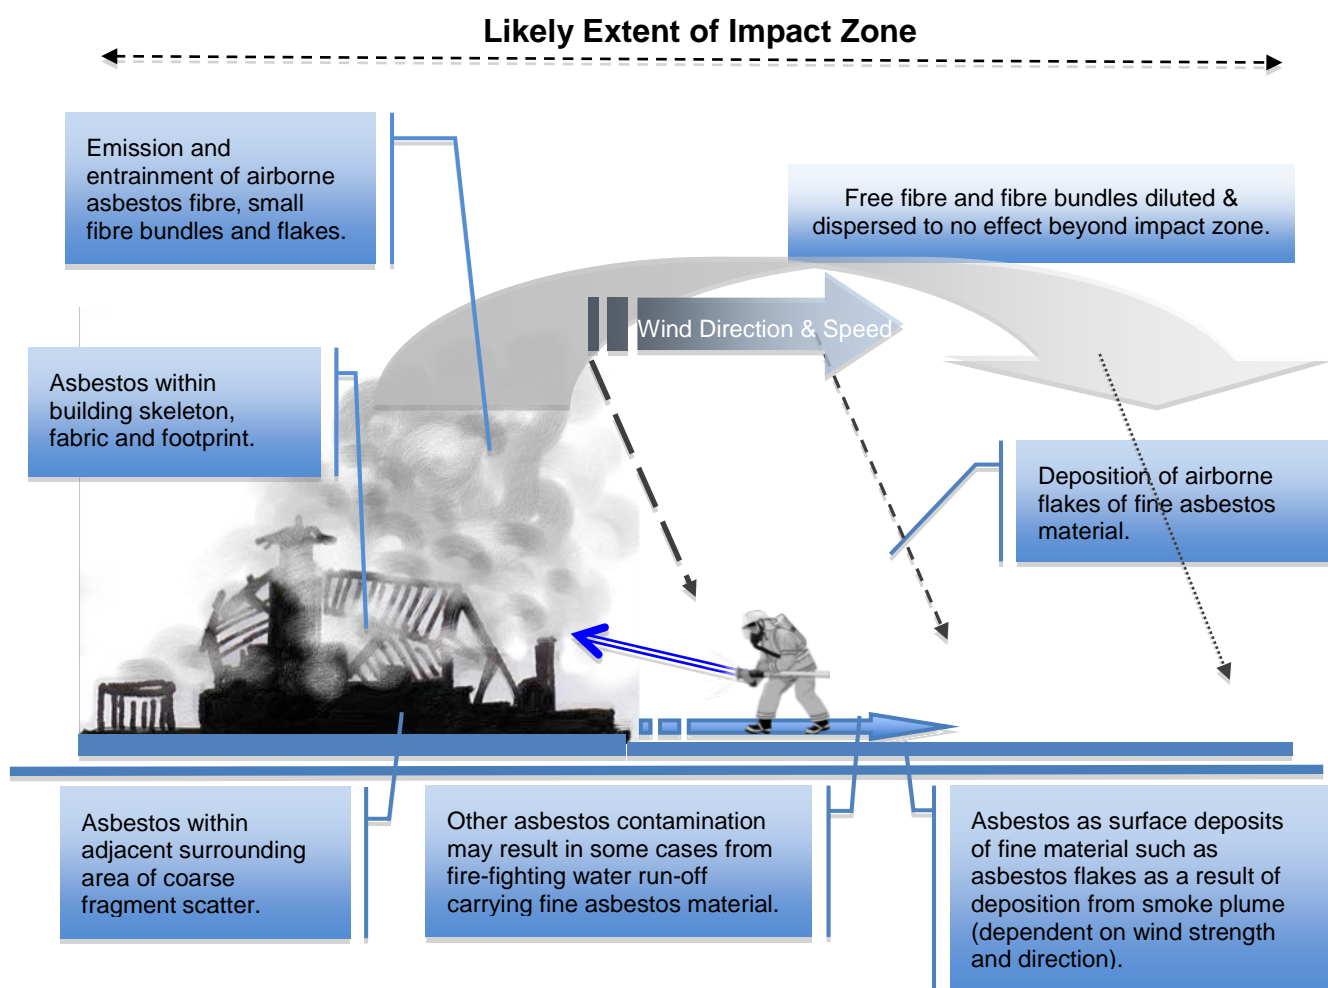
Figure 1 – Asbestos Impacted Fire Scene

Asbestos contamination may be divided loosely into the following four general types:

- building skeleton and footprint;
- adjacent circular area of coarse fragment scatter;
- surface deposits of fine material (such as flakes) as a result of deposition from the smoke plume (dependent on wind direction and strength); and
- airborne free fibre and small fibre bundles.

Other contamination may also result in some cases from fire fighting water runoff carrying fine asbestos material. These different types of impacts are shown in Figure 1.

The building skeleton and footprint contamination is usually readily managed because it is localised, however it may not be possible to separate the asbestos materials from other building debris. The dispersed coarse fragments and fine material often require more specialised management because they have spread into other areas and may have contaminated soils and a surrounding built environment. Studies have shown that the free fibre and fibre bundles released by the fire are greatly dispersed and diluted to the extent that they are comparable with background levels in air, and therefore pose a very low risk. However, it is important to also manage public perception otherwise.

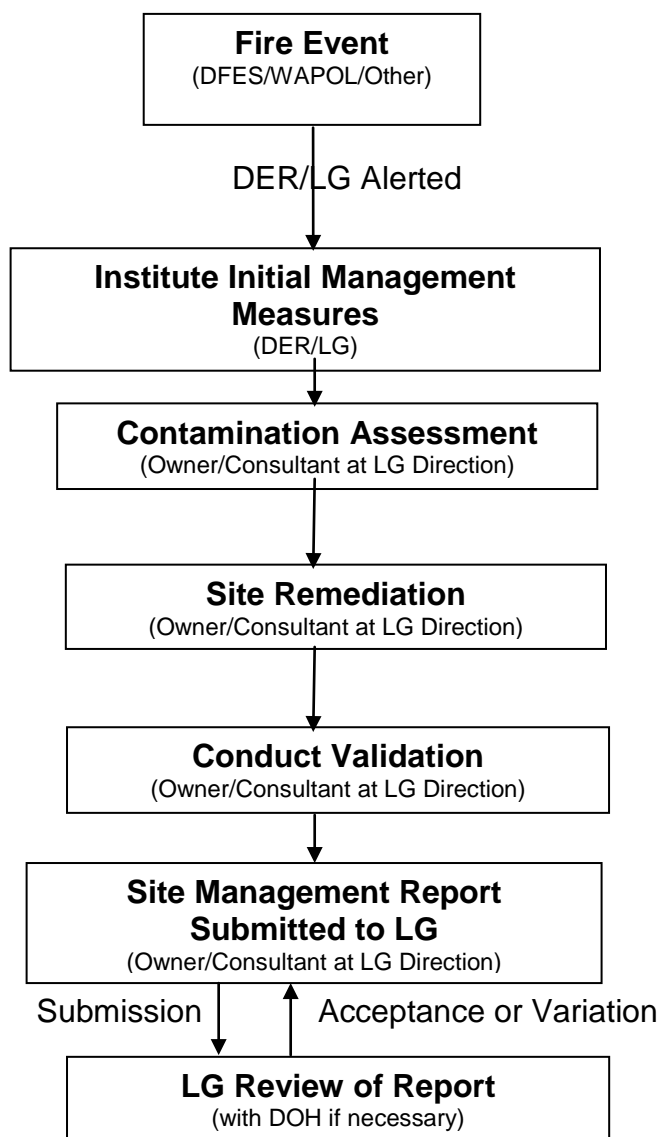
FIGURE 2 - Asbestos fire response and management process

Figure 2 provides an outline of the generalised management process. More detailed information is included in the following sections. Attachment 1 comprises a checklist for the implementation of the series of management measures - not all steps may be required for simpler or more limited contamination situations.

For easy reference to the management process see the Figure 2 flowchart on page 5 and the management checklist on page 17. Not all steps may be necessary for simpler or more limited contamination situations.

Also for ease of use, please consult the procedural flow diagram (Figure 2) on page 5 and the management checklist (Appendix 1) on page 17.

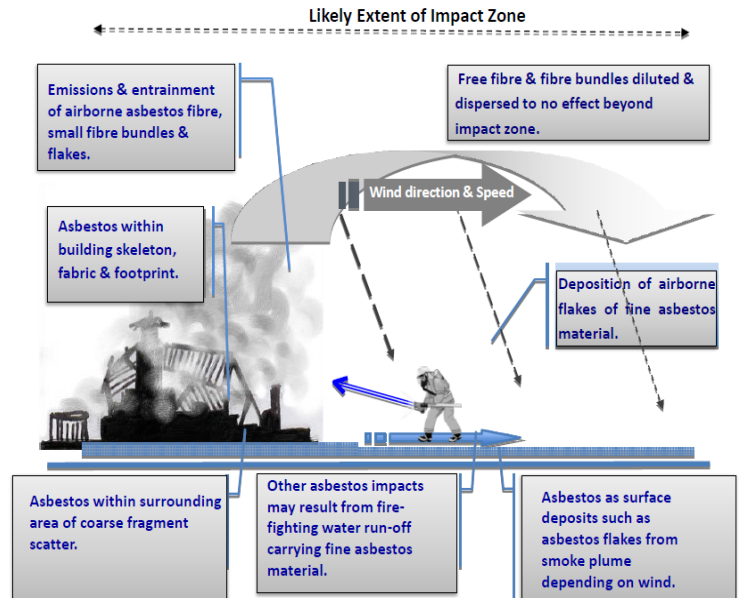
For asbestos cement sheets (10-15% asbestos), this damage often occurs as shattering from the explosive release of contained moisture into sheeting pieces and flakes as shown. The fire asbestos impact areas include;
